TITLE: The Role of Manufacturing Defects in Munition Component Failures

TITLE: New Frontiers in Integrated Diagnostics and Prognostics.  
Proceedings of the 55th Meeting of the Society for Machinery Failure  
Prevention Technology. Virginia Beach, Virginia, April 2 - 5, 2001

## THE ROLE OF MANUFACTURING DEFECTS IN MUNITION COMPONENT FAILURES

Marc Pepi

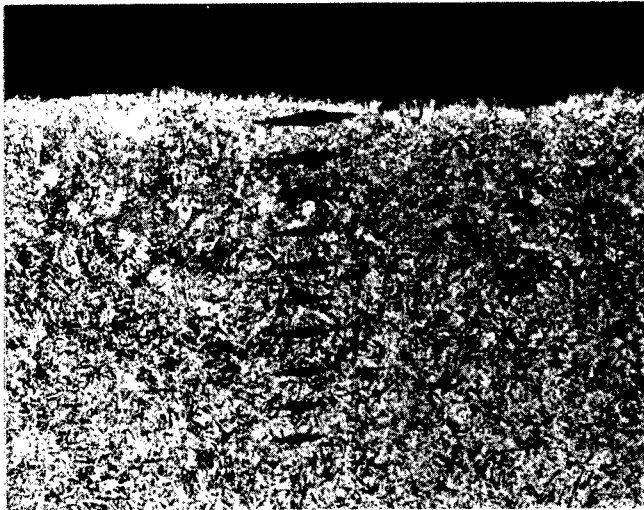
**Results of Investigation:** Visual examination of the individual locking block revealed corrosion and a rougher than nominal surface finish. Metallography revealed a *complete* layer of decarburization along the periphery of the component, which was prohibited according to the governing specification. The depth of decarburization was greater than specified (0.006 vs. 0.003-inch). Hardness testing showed that the entire component (not just the area above the bail, as specified) was hardened to 50 – 55 HRC, not 38 – 43. Hardness testing also showed a loss of surface hardness due to the presence of the decarburization (~20 HRC at the surface, as opposed to 50 – 55 HRC elsewhere). Figure 6 shows a Knoop microhardness profile through the decarburized layer. Note the larger surface readings corresponding to a lower hardness. In addition, the unused top and bottom bolt shafts were not nitrided, as confirmed through metallography and microhardness testing. These components also had a higher than specified silicon content by almost double. Finally, both of the spiral spring pins failed to achieve the 3,900-pound double shear load. One of these pins contained carbon approximately 10 times the requirement, which could have attributed to the poor double shear results.

**Effect of Manufacturing Defects on Performance:** With respect to chemistry, the silicon content of maraging steels should not exceed the maximum limit, since the notch tensile strength [7], as well as the toughness [8] have been shown to be detrimentally affected. Concerning heat treatment, decarburization is a loss of carbon from the surface of a hardened steel part usually caused by an excessively high dew point or low carbon potential during the diffusion portion of a carbide-diffuse cycle, or of prolonged reheating in moist air or other decarburizing gas [9]. A complete decarburized layer consists of ferrite, which transitions to a layer of ferrite plus a low-carbon martensite towards the core of the component, followed by the normal tempered martensitic structure. The presence of decarburization acts to lower the surface hardness of a component, as was shown during the ARL analysis. Decarburization also affects the wear and fatigue resistance of a component. Finally, the effect of a lack of nitriding on a maraged steel component was shown by the in-service fatigue failure. Nitriding of maraging steels is performed to provide resistance to wear and fatigue [10], and should not have been neglected given the application.

**Figure 6** Microstructure of a locking block that contained decarburization. Note the softer surface indicated by the larger Knoop microhardness readings. Mag. 200x.

**Outcome:** The quality and workmanship of the “after-market” components were poor, and these components should never have made their way into service. A First Article Inspection at the “after-market” manufacturing facility should have revealed these detrimental anomalies. The ARL results were presented to both the Air Force (procuring activity) and the NAWC (receiving activity).
